# Uniform Mitigation Verification Inspection Form

| Owner Information <b>BLDG J</b> | | | |
| Owner Name: Camelot Condo Association | | Contact Person: Camelot Condo Associ... | |
| Address: 3103 Sir Hamilton Cir | | Home Phone: | |

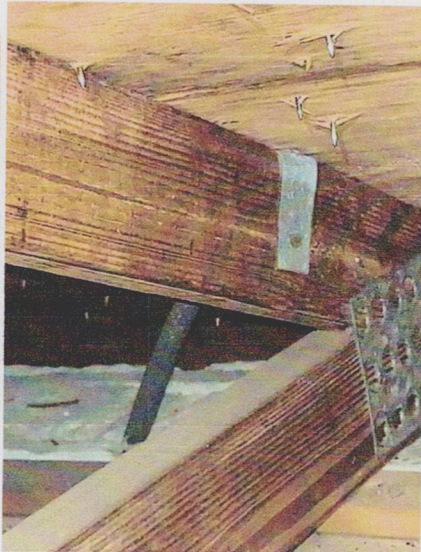
- ☐ Truss/rafter anchored to top plate of wall using nails driven at an angle through the truss/rafter and attached to the top plate of the wall, or
- ☒ Metal connectors that do not meet the minimal conditions or requirements of B, C, or D

Toe Nailed (Metal connectors that do not meet the minimum requirements)
