# Uniform Mitigation Verification Inspection Form

| Owner Information <span style="float: right;">BLDG Q</span> | | |
| Owner Name: Camelot Condo Association | Contact Person: Camelot Condo Associ... | |
| Address: 3033 Sir Hamilton Cir | Home Phone: | |

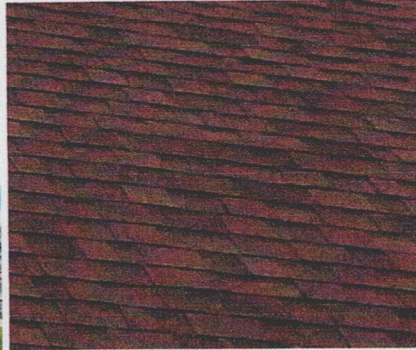
| 2.1 Roof Covering Type | Permit Application Date | FBC or MDC Product Approval # | Year of Original Installation or Replacement | No Information Provided for Compliance |
|---|---|---|---|---|
| <input checked="" type="checkbox"/> 1. Asphalt/Fiberglass Shingle | 12/26/2022 | PBP22-S222 | | <input type="checkbox"/> |

- ☒ A. All roof coverings listed above meet the FBC with a FBC or Miami-Dade Product Approval listing current at time of installation OR have a roofing permit application date on or after 3/1/02 OR the roof is original and built in 2004 or later.

Roof Covering

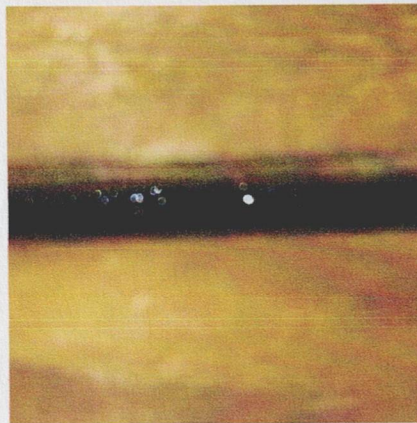
- ☒ A. SWR (also called Sealed Roof Deck) Self-adhering polymer modified-bitumen roofing underlayment applied directly to the sheathing or foam adhesive SWR barrier (not foamed-on insulation) applied as a supplemental means to protect the dwelling from water intrusion in the event of roof covering loss.
- ☐ B. No SWR.
- ☐ C. Unknown or undetermined.

SWR

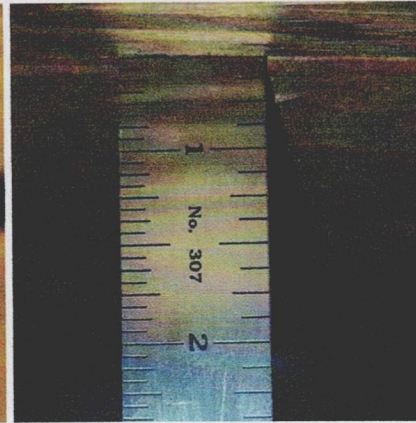
- ☒ C. Plywood/OSB roof sheathing with a minimum thickness of 7/16" inch attached to the roof truss/rafter (spaced a maximum of 24" inches o.c.) by 8d common nails spaced a maximum of 6" inches in the field. -OR- Dimensional lumber/Tongue & Groove decking with a minimum of 2 nails per board (or 1 nail per board if each board is equal to or less than 6 inches in width). -OR- Any system of screws, nails, adhesives, other deck fastening system or truss/rafter

Sheathing

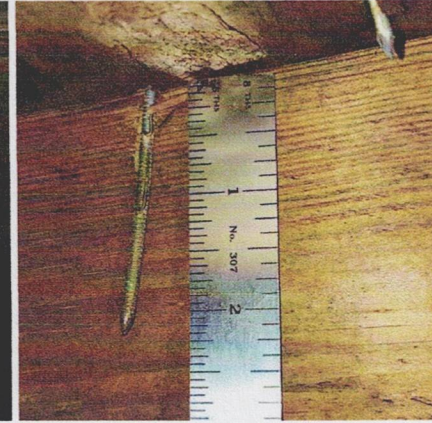
8D Nails

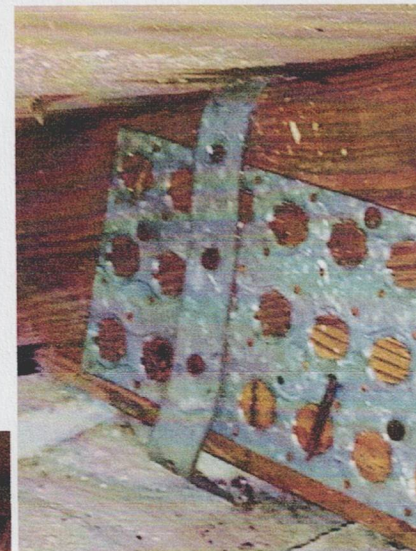
☒ C. Single Wraps

Metal connectors consisting of a single strap that wraps over the top of the truss/rafter and is secured with a minimum of 2 nails on the front side and a minimum of 1 nail on the opposing side.

Single Wraps

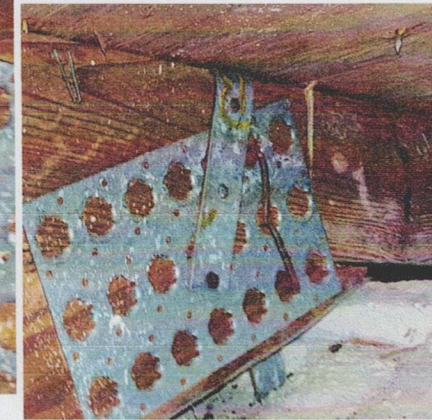
spacing that is shown to have an equivalent or greater resistance than 8d common nails spaced a maximum of 6 inches in the field or has a mean uplift resistance of at least 182 psf.

6 Inch Spacing

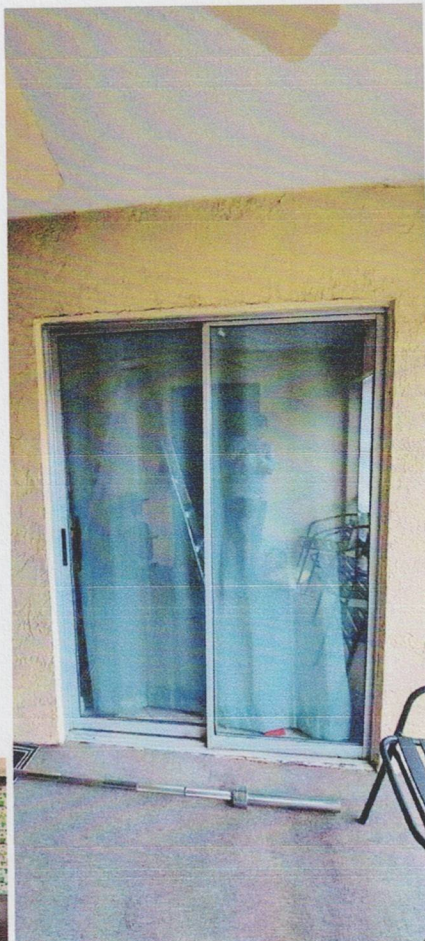
| Opening Protection Level Chart<br>Place an "X" in each row to identify all forms of protection in use for each opening type. Check only one answer below (A thru X), based on the weakest form of protection (lowest row) for any of the Glazed openings and indicate the weakest form of protection (lowest row) for Non-Glazed openings. | | Glazed Openings | | | | Non-Glazed Openings | |
|---|---|---|---|---|---|---|---|
| X | No Windborne Debris Protection | X | | | | X | |

Unprotected glazed entry door

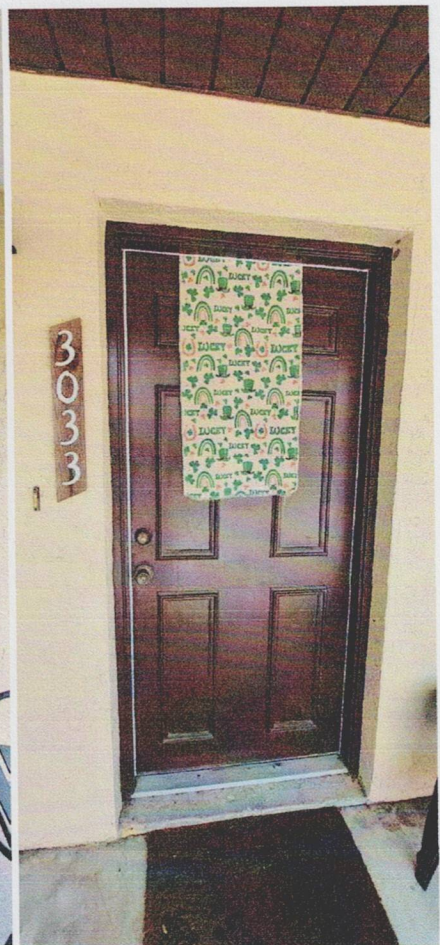
Unprotected non-glazed entry door
