# Uniform Mitigation Verification Inspection Form

| Inspection Date: <b>09/16/2023</b> | | | |
| Address: <b>3027 Sir Hamilton Cir</b> | | Home Phone: | |

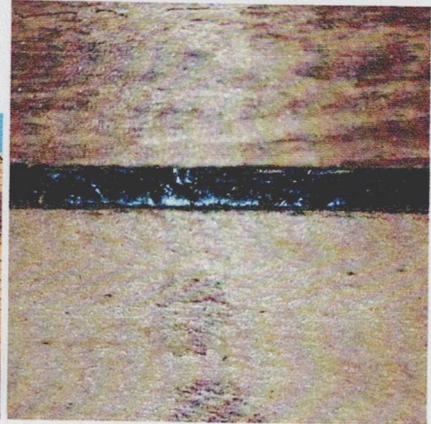
- ☒ A. SWR (also called Sealed Roof Deck) Self-adhering polymer modified-bitumen roofing underlayment applied directly to the sheathing or foam adhesive SWR barrier (not foamed-on insulation) applied as a supplemental means to protect the dwelling from water intrusion in the event of roof covering loss.
- ☐ B. No SWR.
- ☐ C. Unknown or undetermined.

SWR

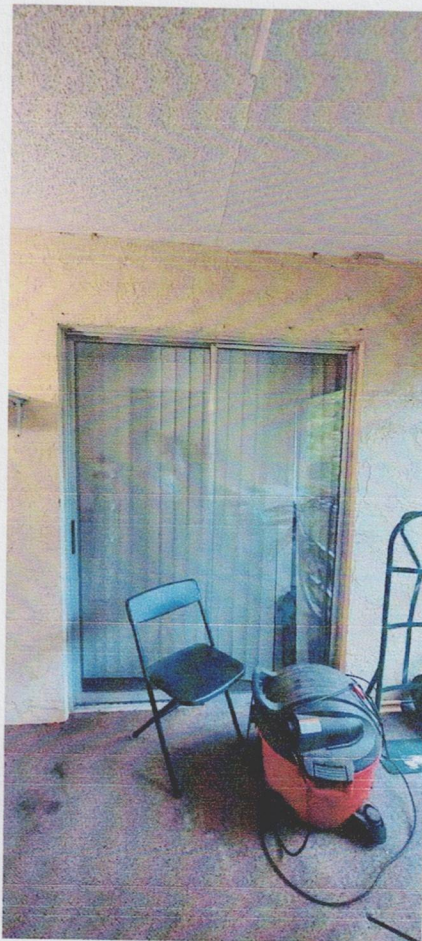
Unprotected glazed entry door

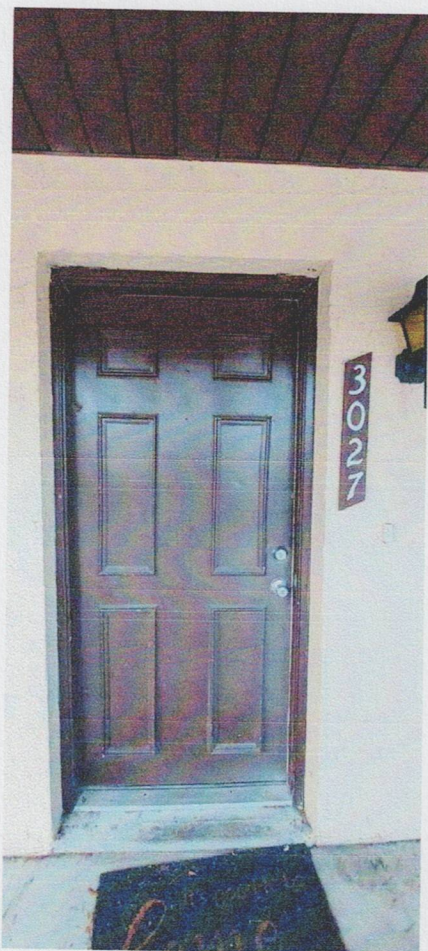
Unprotected non-glazed entry door
