Uniform Mitigation Verification Inspection Form

Inspection Date: 02/09/2017		
Owner Information		
Owner Name: Hidden Harbor Condominiums		Contact Person:
Address: 5801 N Atlantic Ave - Building 2		Home Phone:
City: Cape Canaveral	Zip: 32920	Work Phone:
County: Brevard		Cell Phone:
Insurance Company:		Policy #:
Year of Home: 1974	# of Stories: 2	Email:

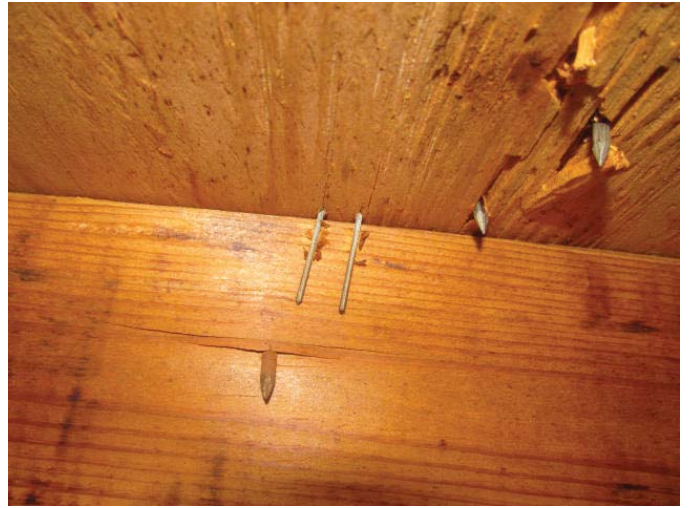
- A. Plywood/Oriented strand board (OSB) roof sheathing attached to the roof truss/rafter (spaced a maximum of 24" inches o.c.) by staples or 6d nails spaced at 6" along the edge and 12" in the field. -OR- Batten decking supporting wood shakes or wood shingles. -OR- Any system of screws, nails, adhesives, other deck fastening system or truss/rafter spacing that has an equivalent mean uplift less than that required for Options B or C below.

Staples

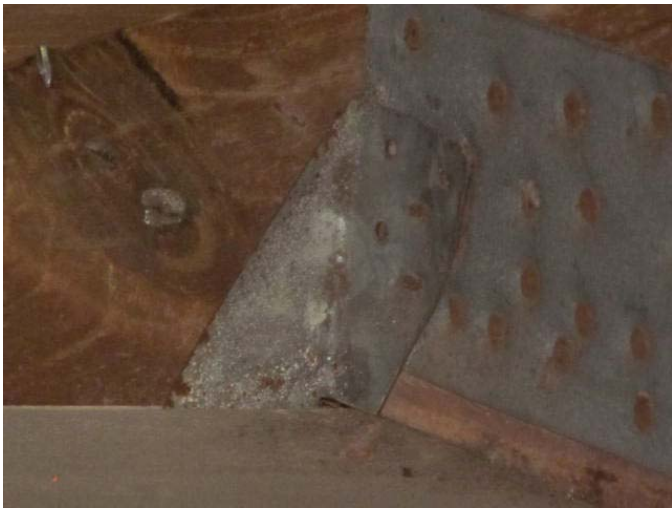
- A. Toe Nails
 - Truss/rafter anchored to top plate of wall using nails driven at an angle through the truss/rafter and attached to the top plate of the wall, or
 - Metal connectors that do not meet the minimal conditions or requirements of B, C, or D

Toe nails - clips with only two nails
