# Uniform Mitigation Verification Inspection Form

Inspection Date: 02/09/2017		
<b>Owner Information</b>		
Owner Name: Hidden Harbor Condominiums		Contact Person:
Address: 5801 N Atlantic Ave - Building 4		Home Phone:
City: Cape Canaveral	Zip: 32920	Work Phone:
County: Brevard		Cell Phone:
Insurance Company:		Policy #:
Year of Home: 1974	# of Stories: 2	Email:

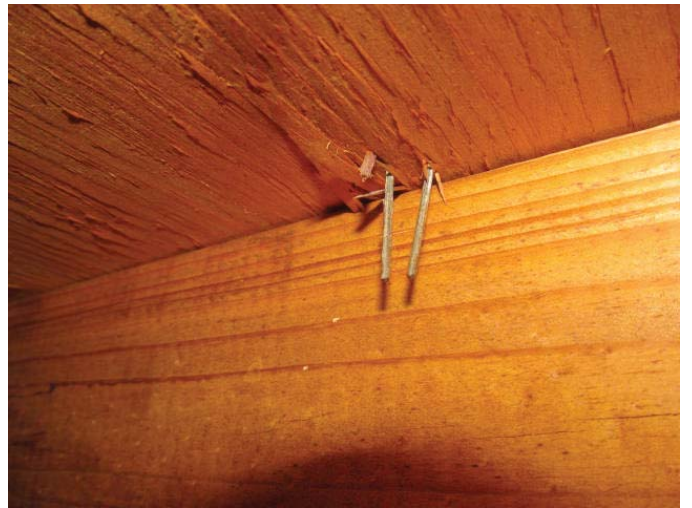
- A. Plywood/Oriented strand board (OSB) roof sheathing attached to the roof truss/rafter (spaced a maximum of 24" inches o.c.) by staples or 6d nails spaced at 6" along the edge and 12" in the field. -OR- Batten decking supporting wood shakes or wood shingles. -OR- Any system of screws, nails, adhesives, other deck fastening system or truss/rafter spacing that has an equivalent mean uplift less than that required for Options B or C below.

Staples

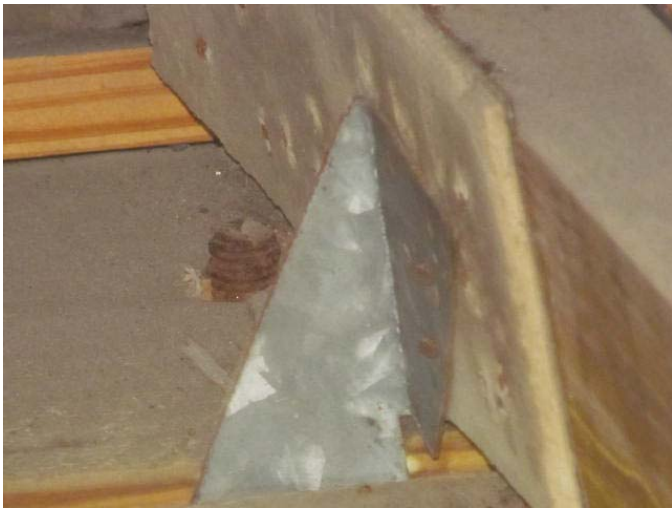
- A. Toe Nails
  - Truss/rafter anchored to top plate of wall using nails driven at an angle through the truss/rafter and attached to the top plate of the wall, or
  - Metal connectors that do not meet the minimal conditions or requirements of B, C, or D

Toe nails - clips with only two nails
